NASA-CR-72713
WANL-PR-(RRR)-001

**EVALUATION OF MECHANICAL PROPERTIES,
OXIDATION RESISTANCE, AND STRUCTURE OF
SLURRY SILICIDE COATED T-222**

Westinghouse Astronuclear Laboratory

December 19, 1969

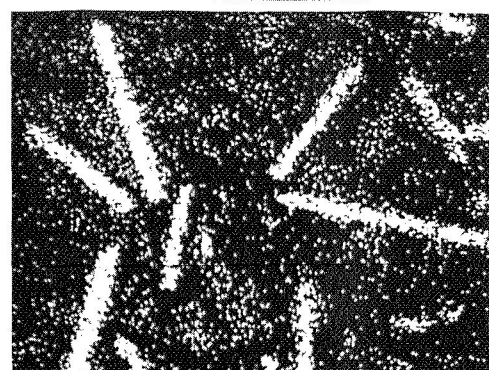
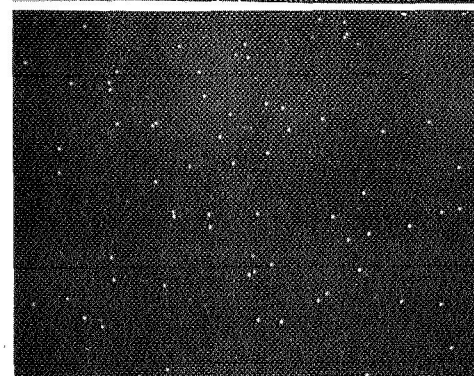
Electron microprobe analysis for the presence of major coating and substrate elements in the two phase surface structure, Figure 26*, revealed the particle phase to be titanium rich, and the matrix silicon rich. Other elements present in the as-applied coating, tungsten, vanadium and molybdenum, were not detected at the primary oxide surface. Similarly, tantalum and hafnium, elements common only to the substrate, did not migrate through the coating to its surface during exposure of the sample.

FIGURE 26 - Concentration of Elements at the Primary Oxide Surface Developed by
Oxidation at 2400°F. Bend Sample 17 Oxidized 134 Hrs/2400°F.
Mag: 500X

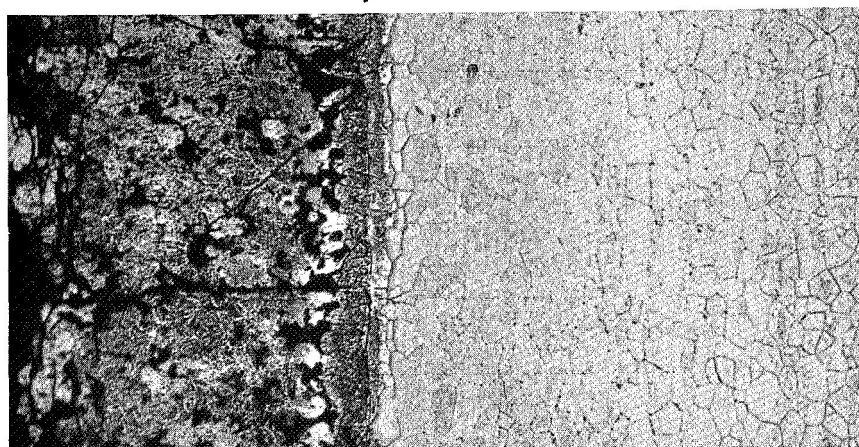
Comparison of total thickness measured at each position reveals position A to be roughly 0.005 inch thinner than the others — Figure 46. Close examination of the mirror image of position A at the other end of creep sample 38, showed the coating at this position to also be noticeably thinner than elsewhere. Other coated samples creep tested on the program were similarly examined and found thin at this region. Total thickness measured at position B was also slightly lower than elsewhere — Figure 47.

Cracks running parallel to the surface are apparent in the outer portion of the metallic-intermetallic reservoir at position A. Cracking is also apparent at position B, but to a much lesser degree than at A — Figure 47. This appears to imply that the coating was not deposited thin in this vicinity of the sample but, instead, was thinned by a process which caused spalling.

FIGURE 47 - Coating and Substrate Structure at Position B on Creep Sample 38
Refer to Figure 39
